DEPARTMENT OF TRANSPORTATION

Contract #: 04-0120F4Cty: SF/ALA Rte: 80 PM: 13.2/13.9File #: 99.28**WELDING INSPECTION REPORT****Resident Engineer:**Siegenthaler, Peter**Address:** 333 Burma Road**City:** Oakland, CA 94607**Report No:** WIR-017491**Date Inspected:** 13-Oct-2010**Project Name:** SAS Superstructure**OSM Arrival Time:** 700**Prime Contractor:** American Bridge/Fluor Enterprises, a JV**OSM Departure Time:** 1900**Contractor:** Zhenhua Port Machinery Company, Ltd (ZPMC)**Location:** Shanghai, China**CWI Name:** Li Yang and Zhu Zhong Hai**CWI Present:** Yes No**Inspected CWI report:** Yes No N/A**Rod Oven in Use:** Yes No N/A**Electrode to specification:** Yes No N/A**Weld Procedures Followed:** Yes No N/A**Qualified Welders:** Yes No N/A**Verified Joint Fit-up:** Yes No N/A**Approved Drawings:** Yes No N/A**Approved WPS:** Yes No N/A**Delayed / Cancelled:** Yes No N/A**Bridge No:** 34-0006**Component:** OBG Trial Assembly**Summary of Items Observed:**

WELDING INSPECTION REPORT

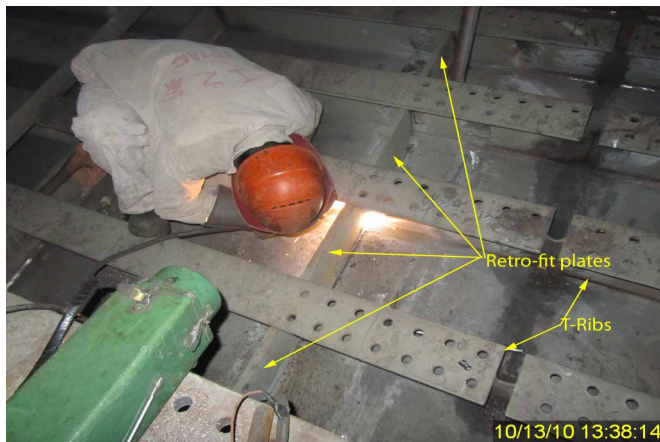
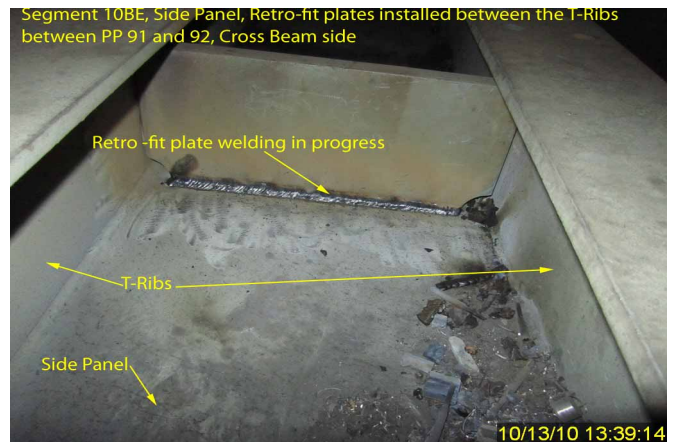
Please reference the pictures attached for more comprehensive details.
